**UNITED STATES DISTRICT COURT
NORTHERN DISTRICT OF CALIFORNIA**

CHART INC.

Case No. 3:20-cv-05010

**COMPLAINT AND
DEMAND FOR JURY TRIAL**

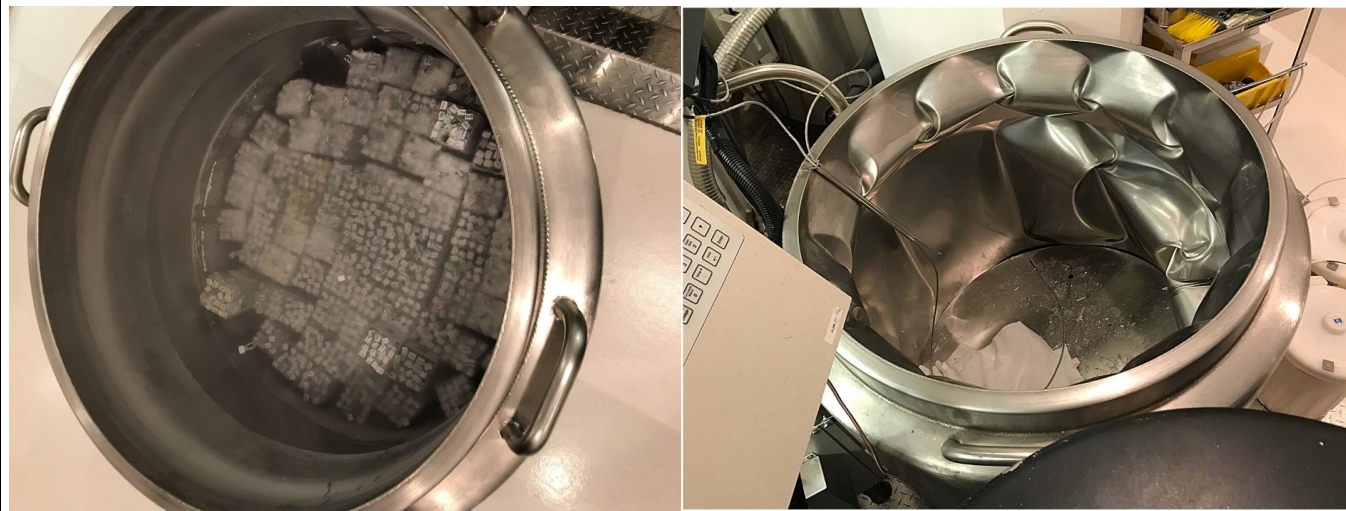
5. The cracked weld also triggered an implosion of the tank's inner vessel, as the liquid nitrogen that was sucked into the vacuum space transitioned to gaseous nitrogen and exerted pressure

on the inner vessel's walls. That is why the lid of the tank was difficult for PFC's embryologists to remove. The imploded tank is shown below, on the right:

Normal Tank

Imploded Tank

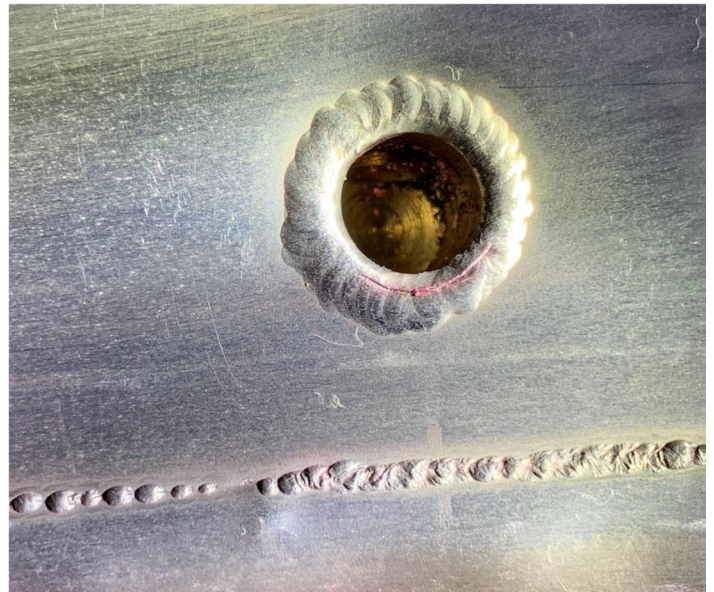
27. The image on the right is the same weld, this time after using Magnaflux Spotcheck liquid dye penetrant. The fact the red dye penetrant remained after the surface was wiped clean is indicative of a crack.

Red dye indicates a crack in the weld
